Instrument Stain Identification & Treatment

Contrary to popular belief the majority of instrument staining problems are not caused by faults within the instruments or the metal used within the manufacturing process. In fact over 95% of instrument staining is caused by incorrect or inadequate cleaning and sterilising processes.

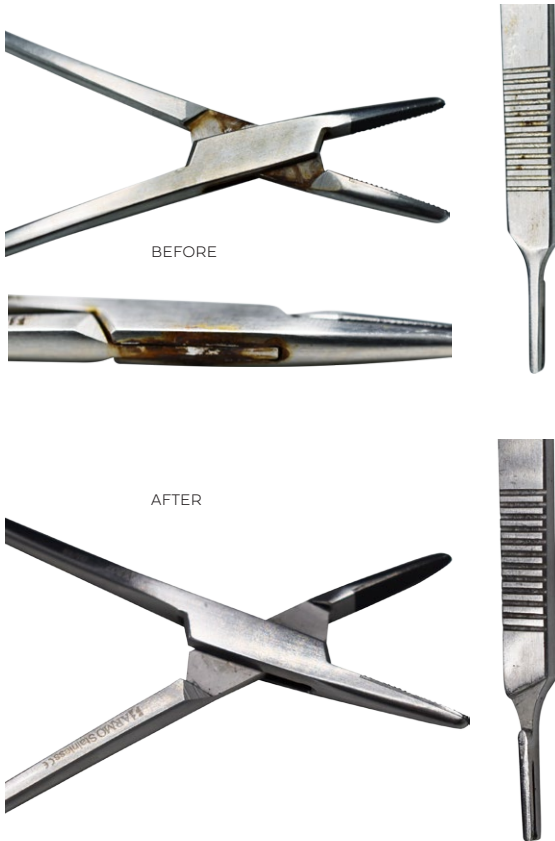
RUST*

CAUSE

- Sterilising instruments of dissimilar metals in same cycle
- Chemicals in detergents or excess amounts of iron or other minerals from local water supply

TREATMENT

- Separate instruments by metal type prior to sterilisation
- Use neutral pH detergents and change to distilled water. Particularly if local water supply is high in iron or other minerals.
- Wipe off residue leaving shiny metal underneath
- Use stain remover on both instruments and autoclave

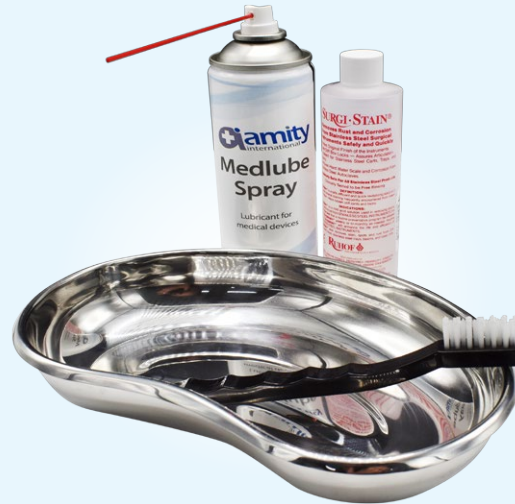
Instrument Maintenance Kit (IMK001)

Contains all you need to revitalise your instruments:

- Surgistain 250ml
- Medlube Spray
- Nylon Brush
- Stainless steel Kidney Dish

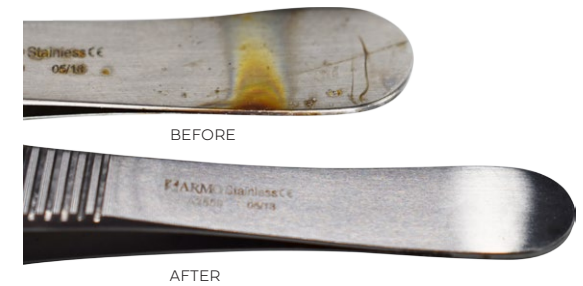
RAINBOW OR MULTI-COLOUR*

CAUSE

- Instruments have been heat compromised, tensile strength could be effected

TREATMENT

- Check the autoclave for proper temperature
- Wash with stain remover

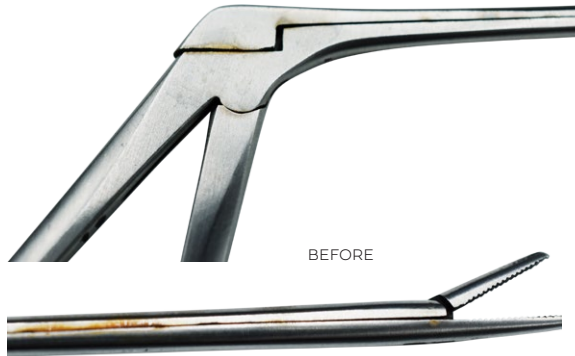
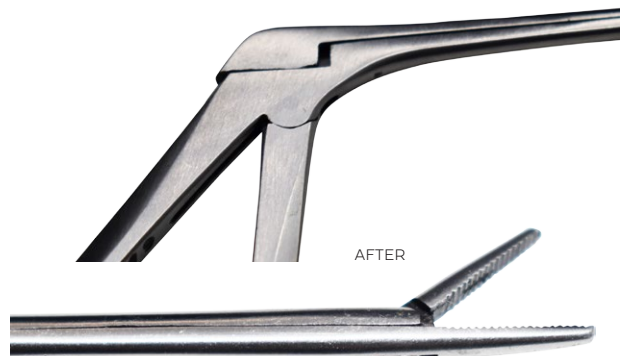
ORANGE-BROWN TO REDDISH* (resembles rust)

CAUSE

If stain rubs off and no pitting exists, problem is most likely to be from:

- Detergent residue on towels or a high Alkaline pH (>8) detergent is being used leaving a phosphate surface deposit
- Dried blood
- Iodine or betadine residue

TREATMENT

- Check pH level of detergent and change to neutral pH detergent
- Check pH of towels to verify if detergent residues are present
- Rinse instruments thoroughly in warm water for a minimum of 30 seconds
- Use a stain remover on both instruments and autoclave
- If problem persists, consider changing to distilled water for rinsing process. Particularly if local water supply is high in iron or other minerals
